**Flood Control Project Maintenance  
Levee Inspections**  
**LMA District Cover Sheet**  
**Spring 2019 Levee Inspection Results**

**Reclamation District No. 2095 Paradise Cut**

**Levee Inspection Report By Mile - Spring 2019**

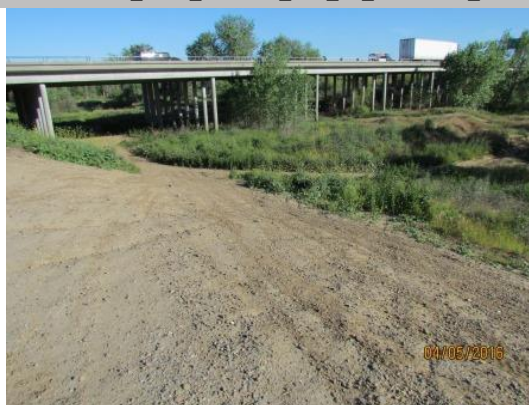
Photo 1 of 1 : SP\_2019\_RD2095\_322\_10\_20190313\_00001.jpg

LM Start	0.15	Rating **	A/W	Issue No.	10
LM End	0.15	Issue Type +	Ma	Location *	WS
Category	Earthen Levee			GPS Latitude/Longitude	
				Start	End
Item	Slope Stability			37.769997 °	37.769997 °
				-121.325055 °	-121.325055 °
DWR ID	DWR_RD2095_01_f_2015_10				
Comment Code					
S3 : Repair the levee slope damaged by vehicle traffic and prevent access where possible.					
Inspector Comment					
LMA is actively controlling access. The slope appears to be stable and should be monitored for possible erosion.

View of the vehicle tracks on the waterside levee slope.

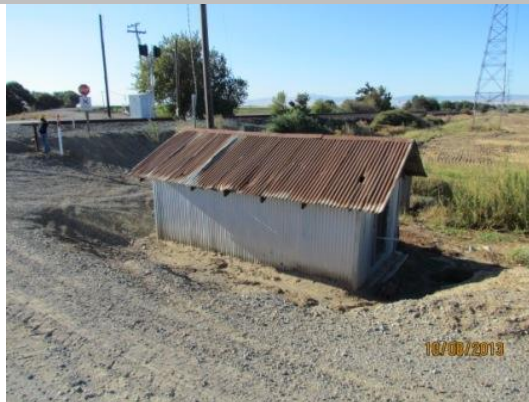
Photo 1 of 1 : SP\_2019\_RD2095\_322\_11\_20190313\_00002.jpg

LM Start	0.71	Rating **	M	Issue No.	11
LM End	0.71	Issue Type +	En	Location *	LS
Category	Earthen Levee			GPS Latitude/Longitude	
				Start	End
Item	Encroachments			37.763630 °	37.763630 °
				-121.319045 °	-121.319045 °
DWR ID	DWR_RD2095_01_s_2012_11				
Comment Code					
BU : Building					
Inspector Comment					
There is a pump house near the railroad.

View of building at the landside levee toe.

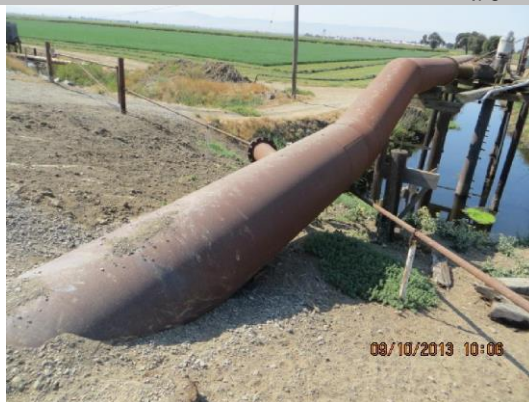
Photo 2 of 3 : UCIP\_SP\_2019\_19812\_33710.jpg

Pipe on LS slope.

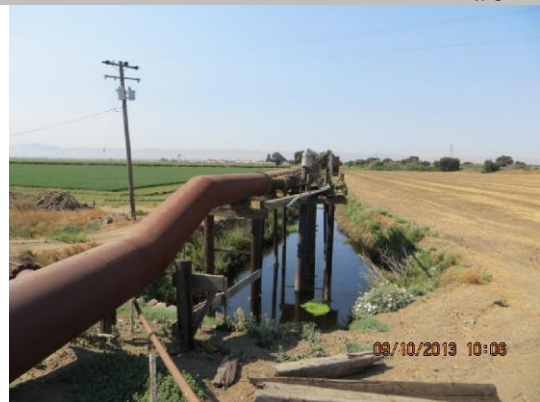
Photo 1 of 3 : UCIP\_SP\_2019\_34387\_62273.jpg

Comment Code					
Inspector Comment					
FS_ID:34387 DS_ID:21629 EP_NO: 6259 Repair Type: Non-Urgent Crossing Status: Found UCIP Comments: What appears to be the concrete headwall on the LS toe is tilting and failing. There is a possibility that the concrete is rubble used to fill in around levee toe. Good candidate for video inspection. FIELD_STRUCT_DESC: 30-inch corrugated metal drainage pipe through the levee, 21 feet below the crown. Slide gate in riser on the waterside (WS) slope. Concrete headwalls and aprons on both ends. Flap gate on the WS end. Two corrugated metal cutoff walls. (Permit No. 6259, 1968 - Everett Farms). [Additional Reference(s): DWR Levee Log, 2005]. FS Date: 9/10/2013

Pipe inlet located below 40-inch pipe at LS toe canal.

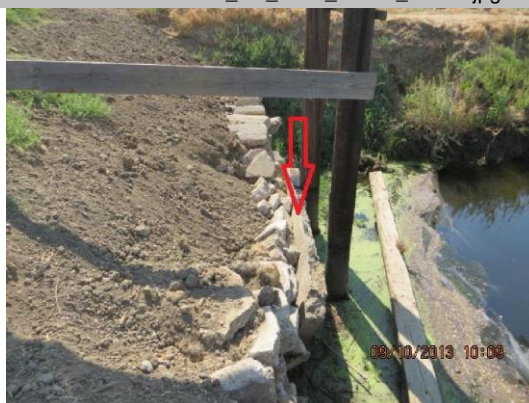
Photo 2 of 3 : UCIP\_SP\_2019\_34387\_62272.jpg

Comment Code						
Inspector Comment						
FS_ID:34387 DS_ID:21629 EP_NO: 6259 Repair Type: Non-Urgent Crossing Status: Found UCIP Comments: What appears to be the concrete headwall on the LS toe is tilting and failing. There is a possibility that the concrete is rubble used to fill in around levee toe. Good candidate for video inspection. FIELD_STRUCT_DESC: 30-inch corrugated metal drainage pipe through the levee, 21 feet below the crown. Slide gate in riser on the waterside (WS) slope. Concrete headwalls and aprons on both ends. Flap gate on the WS end. Two corrugated metal cutoff walls. (Permit No. 6259, 1968 - Everett Farms). [Additional Reference(s): DWR Levee Log, 2005]. FS Date: 9/10/2013

Concrete headwall on LS toe is tilting heavily towards canal.

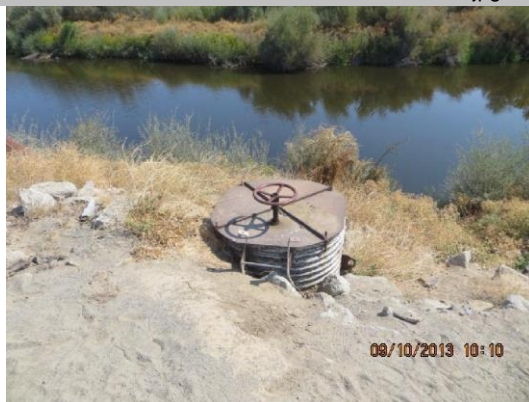
Photo 3 of 3 : UCIP\_SP\_2019\_34387\_62271.jpg

Slide gate in 48-inch CMP riser on WS shoulder.

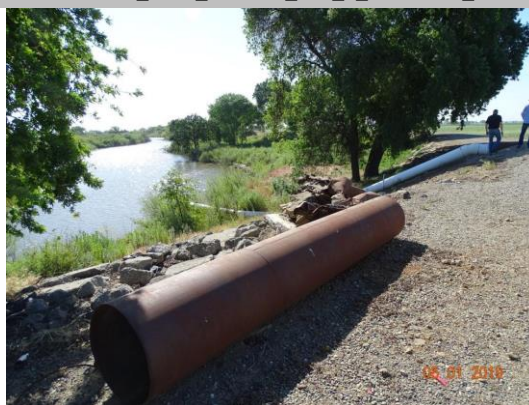
Photo 1 of 1 : SP\_2019\_RD2095\_322\_9\_20190514\_00016.jpg

LM Start	0.90	Rating **	U	Issue No.	9
LM End	0.90	Issue Type +	En	Location *	WS
Category	Earthen Levee			GPS Latitude/Longitude	
				Start	End
Item	Encroachments			37.761134 °	37.761134 °
				-121.317623 °	-121.317623 °
DWR ID	DWR_RD2095_01_s_2019_9				
Comment Code					
DE : Debris					
Inspector Comment					
There is an abandoned pipe on waterside crown.

View of abandoned pipe on waterside crown shoulder. (Spring 2019)

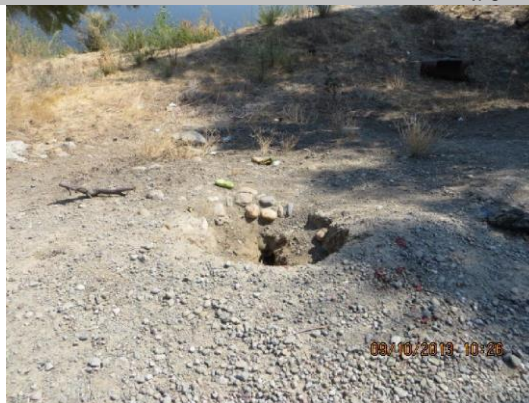
Photo 1 of 3 : UCIP\_SP\_2019\_19815\_33719.jpg

LM Start	0.91	Rating **	M	Issue No.	22
LM End	0.91	Issue Type +	En	Location *	
Category	Supplemental			GPS Latitude/Longitude	
				Start	End
Item	DWR UCIP Field Study			37.761079 °	37.761079 °
				-121.317567 °	-121.317567 °
DWR ID	21630				
Comment Code					
Inspector Comment					
FS_ID:19815 DS_ID:21630 EP_NO: N/A Repair Type: Non-Urgent Crossing Status: Indicator Found UCIP Comments: Pipe abandoned and should be verified as having been done so properly. FIELD_STRUCT_DESC: *ABANDONED* 12-inch steel drainage pipe through the levee, 1.5 feet below the crown. Pump on pile structure in drainage ditch on the landside (LS). Siphon breaker in steel standpipe on the waterside (WS) slope. [Additional Reference(s): DWR Levee Log, 2005. USACE San Joaquin O&M Manual 10, March 1964, (HLM 0.92)]. FS Date: 9/10/2013

Hole on LS shoulder where standpipe may have been located.

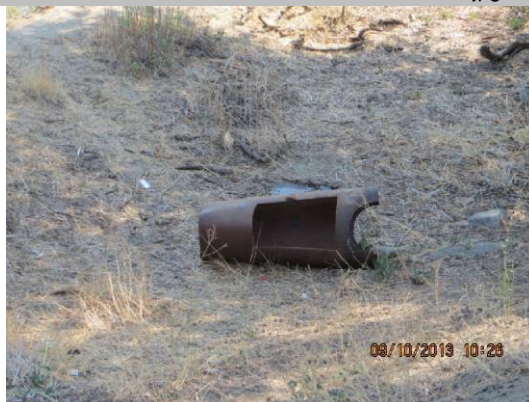
Photo 2 of 3 : UCIP\_SP\_2019\_19815\_33718.jpg

Standpipe discarded on WS berm.

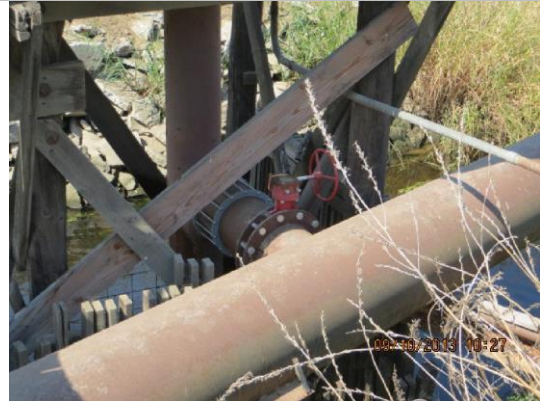
Photo 3 of 3 : UCIP\_SP\_2019\_19815\_33717.jpg

Possible location of 12-inch pipe connection to pump on LS toe.

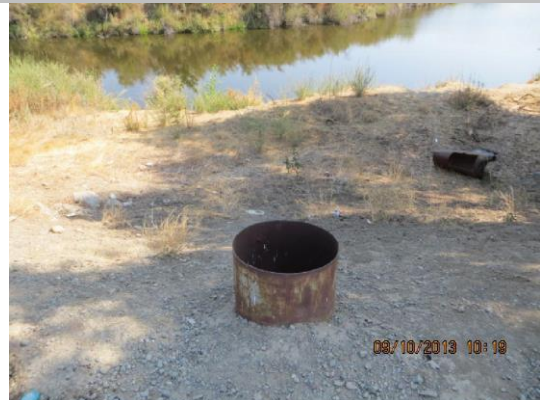
Photo 1 of 3 : UCIP\_SP\_2019\_19813\_33715.jpg

Comment Code						
Inspector Comment						
FS_ID:19813						
DS_ID:21631						
EP_NO: 6537						
Repair Type: Non-Urgent						
Crossing Status: Found						
UCIP Comments: Corroded holes on pipe at outlet WS toe, good indication of internal pipe condition. Good candidate for video inspection.						
FIELD_STRUCT_DESC: 14-inch steel drainage discharge pipe through the levee, 2.5 feet below the crown. Pump on pile structure in drainage ditch on the landside (LS). Siphon breaker in 24-inch corrugated metal pipe (CMP) riser on the waterside (WS) shoulder. Flap gate on the WS end. (Permit No. 6537, 1969 - Everett Farms). [Additional Reference(s): DWR Levee Log, 2005].						
FS Date: 9/10/2013

Siphon Breaker/vent in 24-inch steel riser on WS shoulder.

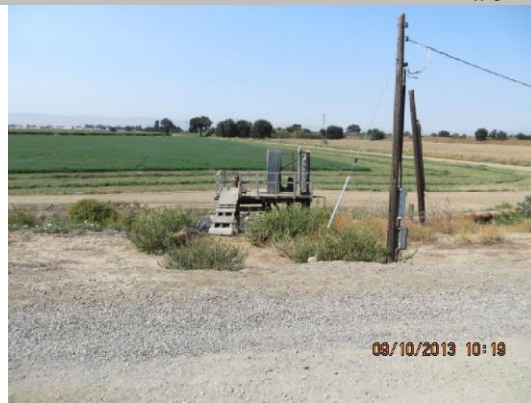
Photo 2 of 3 : UCIP\_SP\_2019\_19813\_33714.jpg

Comment Code						
Inspector Comment						
FS_ID:19813 DS_ID:21631 EP_NO: 6537 Repair Type: Non-Urgent Crossing Status: Found UCIP Comments: Corroded holes on pipe at outlet WS toe, good indication of internal pipe condition. Good candidate for video inspection. FIELD_STRUCT_DESC: 14-inch steel drainage discharge pipe through the levee, 2.5 feet below the crown. Pump on pile structure in drainage ditch on the landside (LS). Siphon breaker in 24-inch corrugated metal pipe (CMP) riser on the waterside (WS) shoulder. Flap gate on the WS end. (Permit No. 6537, 1969 - Everett Farms). [Additional Reference(s): DWR Levee Log, 2005]. FS Date: 9/10/2013

Pump on wooden pier at LS toe.

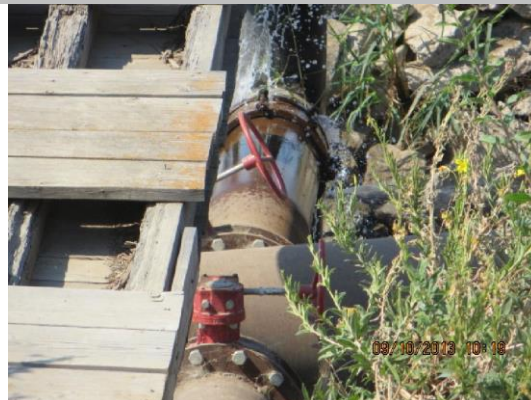
Photo 3 of 3 : UCIP\_SP\_2019\_19813\_33713.jpg

Butterfly valve at pump on LS toe.

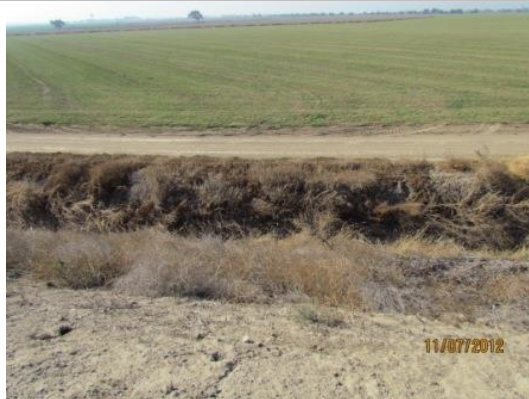
Photo 1 of 1 : SP\_2019\_RD2095\_323\_5\_20190313\_00005.jpg

View of a ditch along the landside toe.

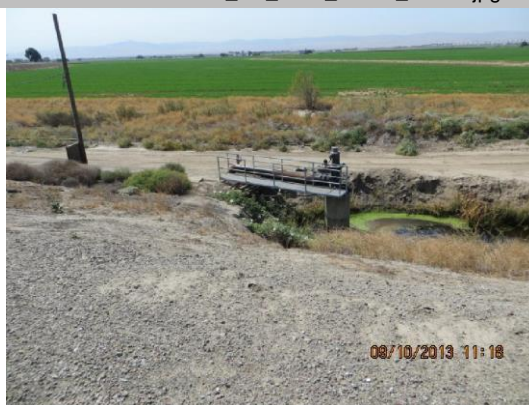
Photo 1 of 1 : UCIP\_SP\_2019\_19863\_33760.jpg

LM Start	1.48	Rating **	M	Issue No.	942
LM End	1.48	Issue Type +	En	Location *	
Category	Supplemental			GPS Latitude/Longitude	
				Start	End
Item	DWR UCIP Field Study			37.743142 °	37.743142 °
				-121.297692 °	-121.297692 °
DWR ID	21642				
Comment Code					
Inspector Comment					
FS_ID:19863 DS_ID:21642 EP_NO: 4658 Repair Type: Non-Urgent Crossing Status: Found UCIP Comments: Pipe appears abandoned in place and re-routed to LM 1.652. Need to verify pipe was properly abandoned. Permit FIELD_STRUCT_DESC: *ABANDONED* 14-inch steel drainage pipe through the levee, 3.5 feet below the crown. Pump on structure over drainage ditch on the landside (LS). Flap gate on the waterside (WS) end. (Permit No. 4658, 1964 - Cochran Company, Inc.). [Additional Reference(s): DWR Levee Log, 2005. USACE San Joaquin O&M Manual 11, 1968, (HLM 1.51)]. FS Date: 9/10/2013

Pump visible on LS toe, but pipe has been re-routed to southwest.

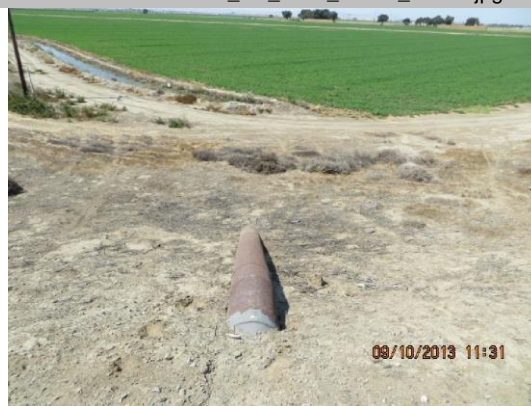
Photo 2 of 3 : UCIP\_SP\_2019\_19866\_33766.jpg

16-inch steel pipe on LS slope.

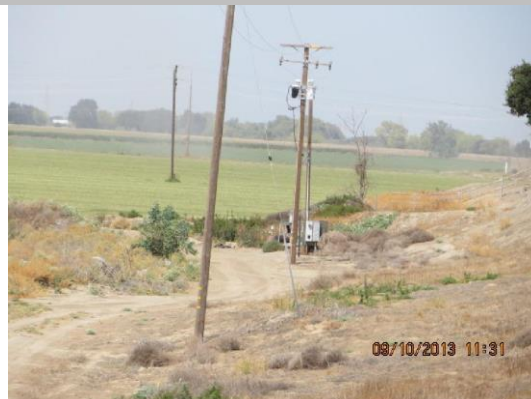
Photo 3 of 3 : UCIP\_SP\_2019\_19866\_33765.jpg

Pump located at levee toe 750-feet north west of pipe crossing.

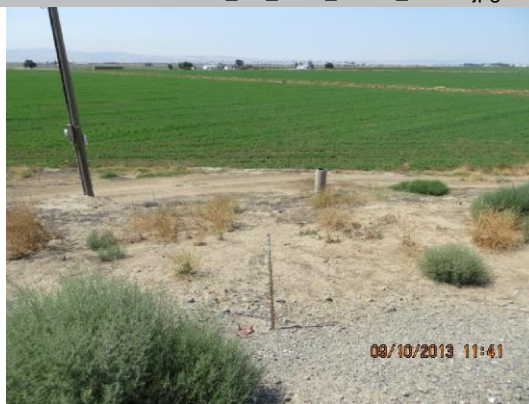
Photo 1 of 3 : UCIP\_SP\_2019\_19867\_33771.jpg

LM Start	2.08	Rating **	M	Issue No.	944
LM End	2.08	Issue Type +	En	Location *	
Category	Supplemental			GPS Latitude/Longitude	
				Start	End
Item	DWR UCIP Field Study			37.735416 °	37.735416 °
				-121.297860 °	-121.297860 °
DWR ID	21643				
Comment Code					
Inspector Comment					
FS_ID:19867 DS_ID:21643 EP_NO: N/A Repair Type: Non-Urgent Crossing Status: Found UCIP Comments: Siphon breaker on LS shoulder does not appear to be functional. FIELD_STRUCT_DESC: 16-inch steel irrigation pipe through the levee, 2 feet below the crown. Slant pump on steel platform on the waterside (WS) slope. Siphon breaker on the landside (LS) shoulder marked by a T-post. Service pole and meter on the LS toe. Possible concrete standpipe on the LS toe. [Additional Reference(s): DWR Levee Log, 2005. USACE San Joaquin O&M Manual 11, 1968, (HLM 2.12)]. FS Date: 9/10/2013

Siphon breaker on LS shoulder next to T-post with Power pole and concrete standpipe on LS toe.

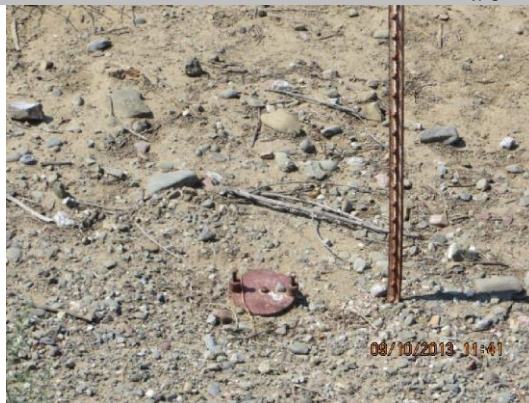
Photo 2 of 3 : UCIP\_SP\_2019\_19867\_33770.jpg

Siphon breaker on LS shoulder next to T-post.

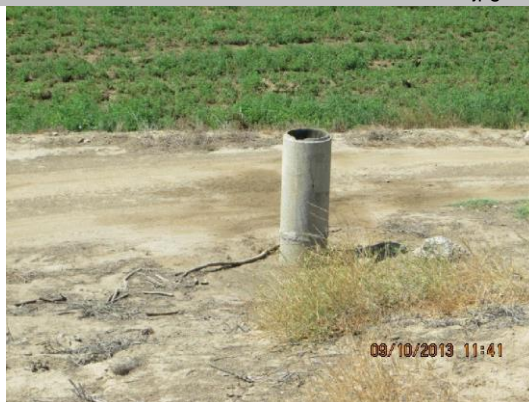
Photo 3 of 3 : UCIP\_SP\_2019\_19867\_33769.jpg

Concrete standpipe on LS toe.

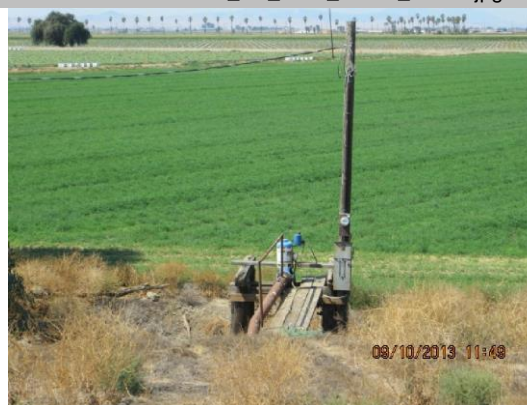
Photo 1 of 2 : UCIP\_SP\_2019\_19871\_33778.jpg

LM Start	2.38	Rating **	A/W	Issue No.	945
LM End	2.38	Issue Type +	Ma	Location *	
Category	Supplemental			GPS Latitude/Longitude	
				Start	End
Item	DWR UCIP LMA Responsibility			37.731313 °	37.731313 °
				-121.298298 °	-121.298298 °
DWR ID	21644				
Comment Code					
Inspector Comment					
FS_ID:19871 DS_ID:21644 EP_NO: N/A Repair Type: No Action Needed Crossing Status: Found UCIP Comments: FIELD_STRUCT_DESC: 8-inch steel drainage pipe through the levee, 3 feet below the crown. Pump in drainage ditch on the landside (LS). Vent pipe at the waterside (WS) toe. 1.5-inch galvanized iron electrical conduit through the levee at the same location. Service pole with a switch box and meter on the LS. [Additional Reference(s): DWR Levee Log, 2005. USACE San Joaquin O&M Manual 11, 1968, (HLM 2.41)]. FS Date: 9/10/2013

Pump on metal pier off LS toe.

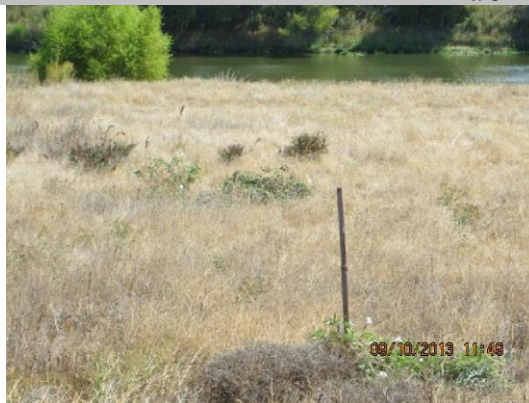
Photo 2 of 2 : UCIP\_SP\_2019\_19871\_33777.jpg

Vent standpipe on WS toe.
